Case study spotlight:

The little things that no longer bug 3M

Providing a full-scale solution to prevent insect infiltration at 3M's manufacturing facility

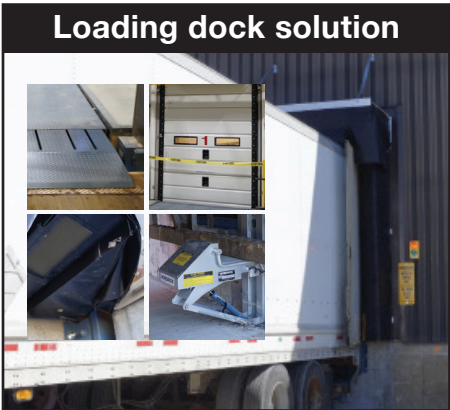
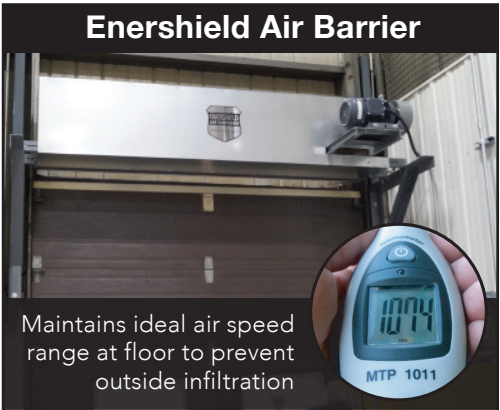
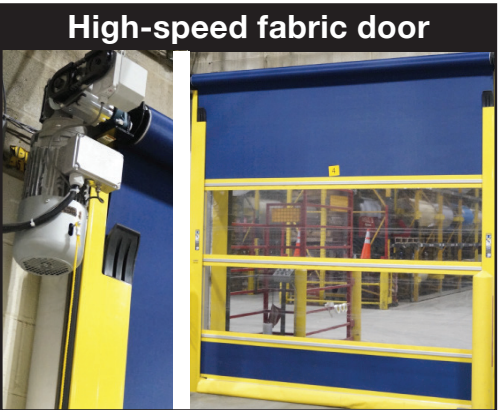
Starting from the outside-in, the warehouse and production areas were equipped with Enershield Air Barriers to seal open doorways by up to 90%. This deterrent blocks outside insects, debris and drafts created by extreme temperatures from entering and contaminating the inside space. In the production area, a complete loading dock solution was installed using foam frame shelters, telescoping-lip dock levelers and impact-resistant MXV sectional doors, which are all designed to increase process speeds and create a tight seal between the trailer and building, even when the bays are not in use. Sealing the outside air off in high-traffic areas also prevented energy loss and lightened the load on 3M's existing HVAC system.

High-speed fabric doors were installed and can open and close by multiple activations including transmitters, push buttons or floor loops. Able to fully open in 3.2 seconds, the doors are programmed to automatically close after 22 seconds (with a fast close time of 5.5 seconds). If insects do make it into the warehouse area, they will be stopped by these high-speed doors. By sealing off outside air, workers were able to increase their productivity and comfort. 3M was also able to adhere to their high quality assurance standards on their manufactured products by now deterring insects.

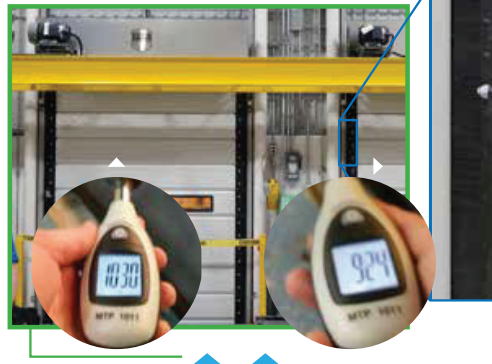
New loading dock doors

- MXV impact dock doors
- Enershield Air Barriers
- Foam frame dock shelters with Rain-Stop
- Telescoping-lip dock levelers
