**Northern**  
**Dock Systems**

**Customer**  
**Success Story**

## Costco 161

Kamloops, BC

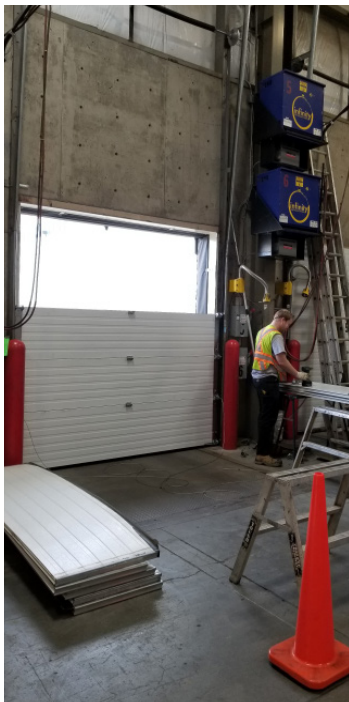
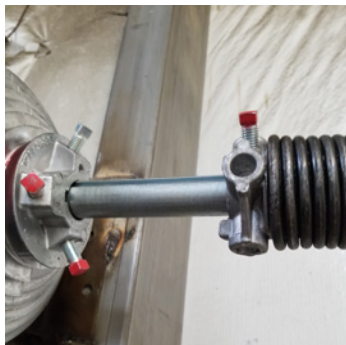
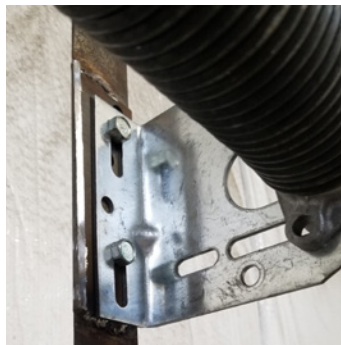
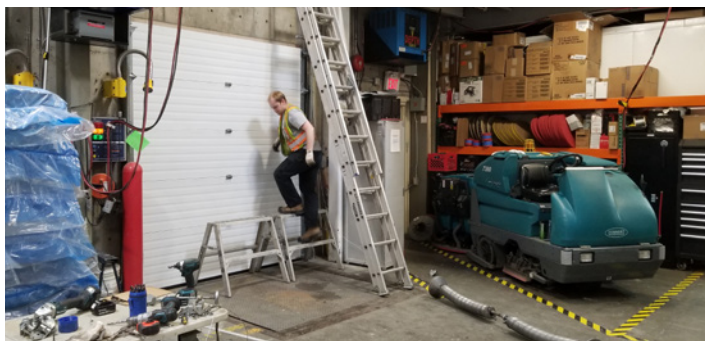
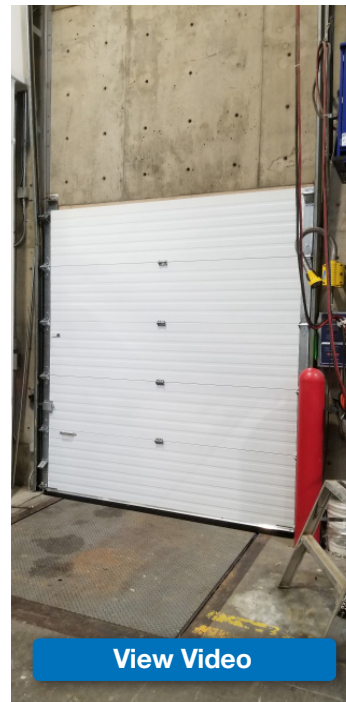
The Costco in Kamloops, BC had 5 receiving doors that were damaged and worn from being hit and heavy use, the panels were creased, springs were worn as were the hinges and rollers. This affected their overall operational efficiency and caused energy loss through the gaps.

After visiting the location in their site audit, Northern Docks Systems determined that the existing door tracks were in great condition since they were protected by bollards and were not damaged. Reusing the existing door tracks helped lower the overall project cost as replacing them would have been expensive because they were fully welded.

NDS replaced the 5 damaged receiving doors with new doors that had rigid polyurethane 1-1/2", R14.25 insulated panels, which created a more energy-efficient environment.

In addition to replacing the doors, all door springs, cables and hardware (except for the tracks) were replaced to ensure the operational efficiency of the doors and to prevent them from breaking down in the near future.

Brush weather seal was also added to the bottom of all the doors to help prevent rodents, insects, debris, outside air and white light from entering the facility. By sealing off the gaps around the door, Costco has ensured the safety of their personnel and products; showing auditors that they are doing their due diligence.
