Manufacturing Plant

Mississauga, ON

Project Overview

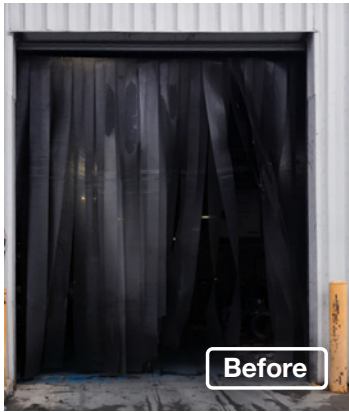
Before

In order to counteract the slow door, strip curtains were added. However, these strip curtains were continuously being damaged and need to be replaced often, which was costly. Moreover, these strip curtains were getting dirty causing low visibility for forklift traffic. Furthermore, the open procedure required for employees to get off the forklift and press the open button exit door then close the door manually or leave it open until they come back in.

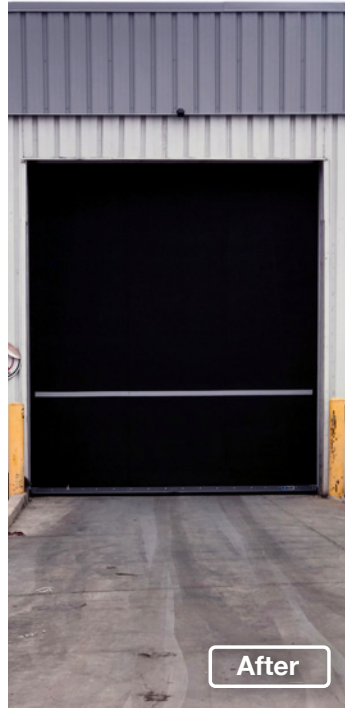
After

They contacted Northern Dock Systems to supply and install a [high-speed heavy duty high cycle rubber door](#) with a timer to close, which would allow for the forklift traffic to exit through the door and then the door shut automatically. Furthermore, the [Falcon motion sensors](#) on both sides of the opening allow forklifts to just drive into view and the door will open and close automatically.
