Embedded Structural Steel Docking Wall and Bollards

Local Grocery Store

London, ON

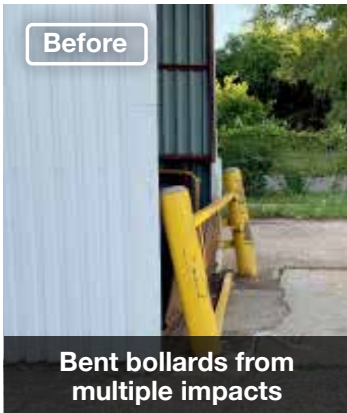
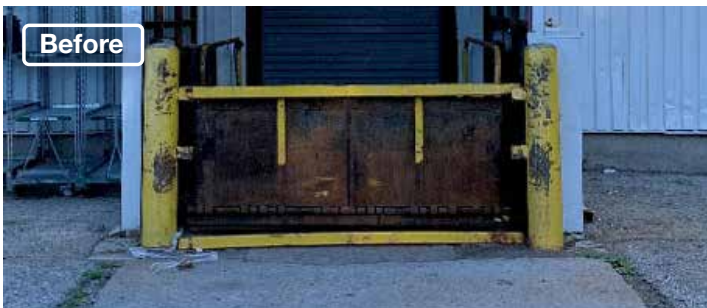
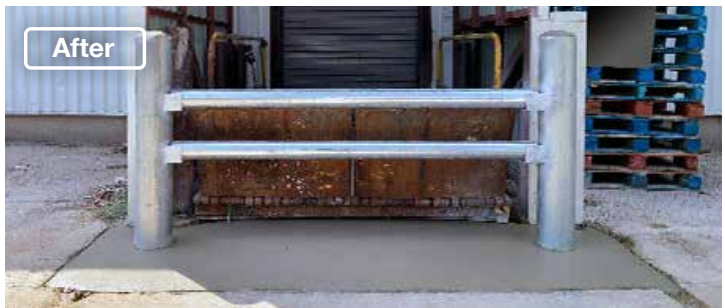
The store's existing bollard system, which protects the exterior-mounted lift table, was severely damaged. Absorbing the impact of countless delivery trucks over the years, left the bollards bent back. As a result, the bent bollards were impacting the walls of the enclosure installed around the lift table and the lift table itself.

In addition, the original concrete piers for the bollards were cracked. For these reasons, it was a difficult loading process with constant risk to the existing equipment and structure.

Northern Dock Systems, in collaboration with one of our trusted partners, was able to complete a full replacement of the existing bollards and install an upgraded docking wall.

All excavation, removal, fabrication, installation, reinforcing and finish concrete work was completed over a two-day period to reduce the service disruption for the grocery store.

This new bollard and structural wall solution will prove to be effective and reliable for countless years to come. We excavated 4' down into the ground along with extending the trenching and concrete from the face of the existing pit to 24" past the face of the bollards. As a result, the new system is sure to stop any reversing truck while maintaining strength and support as not to crack over time.

Furthermore, the galvanized pipe bollards and cross tubes are well suited for the exterior environment and weather. Additionally, with the cross tubes being removable, the store is

Extracted the existing bollards
Installed new bollards
Finished the new exterior concrete apron
