Dock Seals and Steel Face Dock Bumpers Good Water Warehouse

Calgary, AB

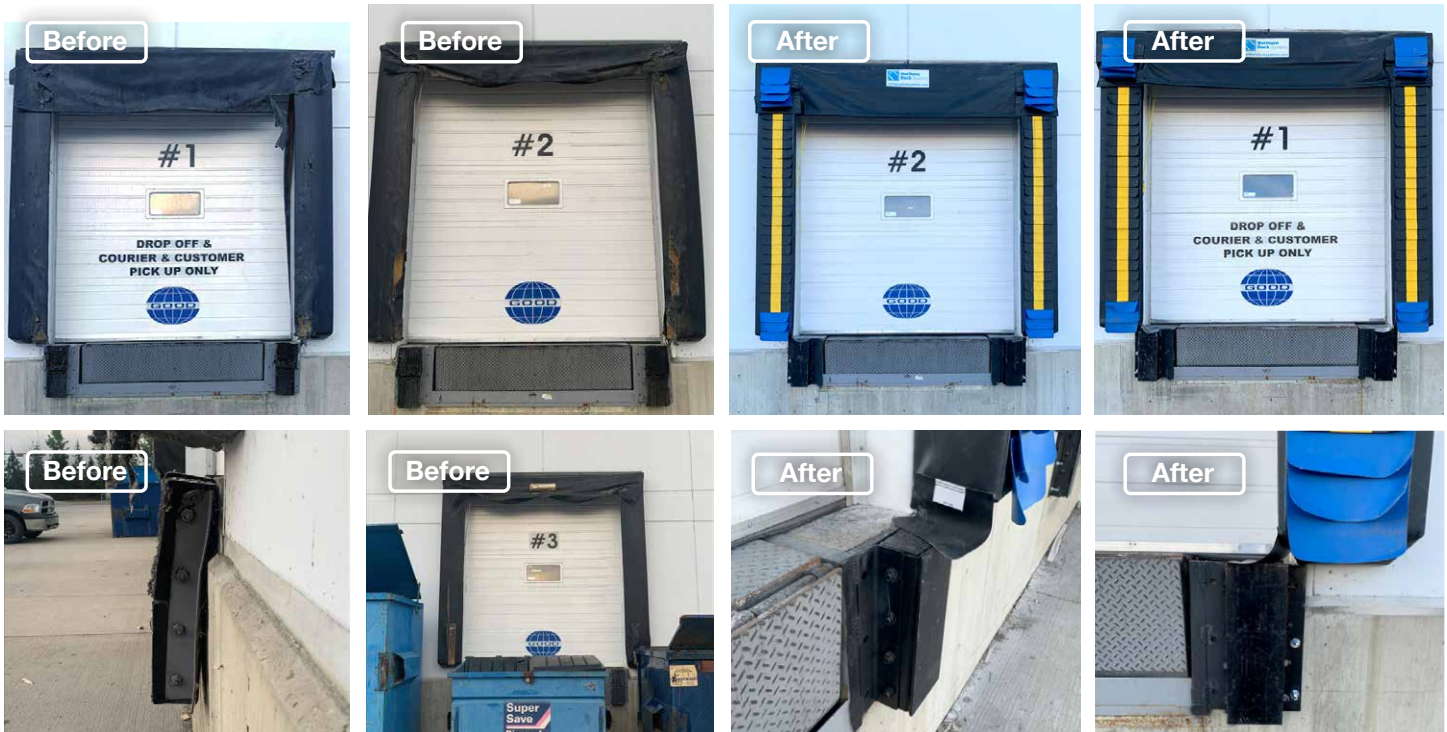
After completing a site check to get the correct measurements, our Project Manager determined that the dock seal was worn down prematurely because of the crushed and worn dock laminate dock bumpers. As a result, there was a loss of projection and the dock seal was over-compressed. Additionally, there was a void behind the dock bumper which is why the old bumpers were being crushed.

The new adjustable head curtain dock seal has 4" wear pleats to provide three layers of protection from wear and tear. At the same time, the yellow guide strip makes it easier for drivers to back into the position.

Additionally, we added corner flaps that cover the gap around the bumpers. This Calgary warehouse has already seen the difference this makes because it has blocked snow from coming in through the doors.

In order to prevent the new dock seals from getting over-compressed, we resolved the underlying issue of filling the void. So the new steel face dock bumpers would not be warped from the void over time. Steel face dock bumpers have a floating steel faceplate that extends the bumper's lifespan. They can withstand frequent impacts in heavy traffic situations.
