# Costco 1169

Mississauga, ON

## Project Overview

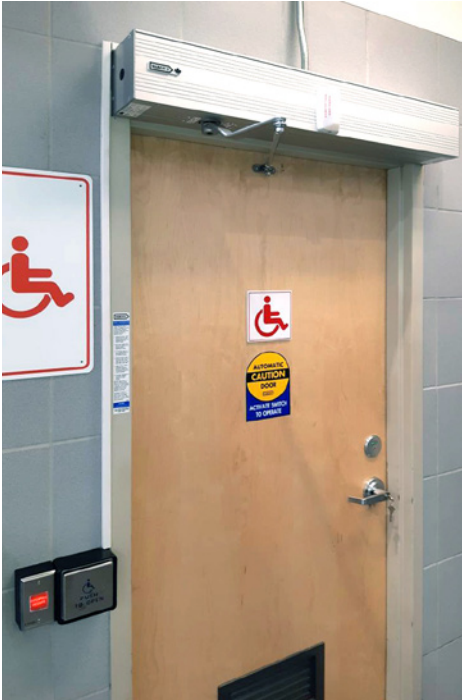
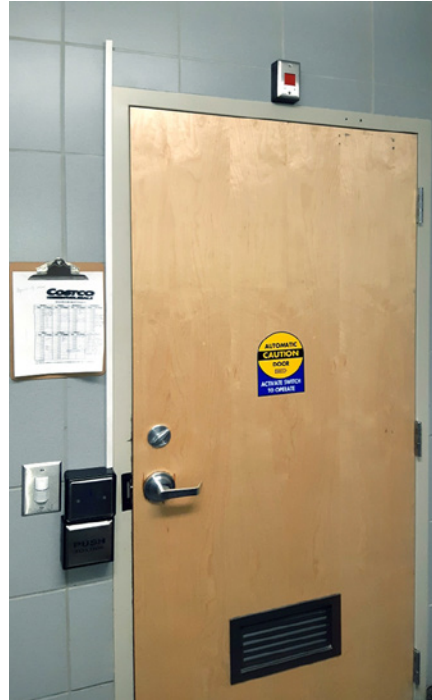
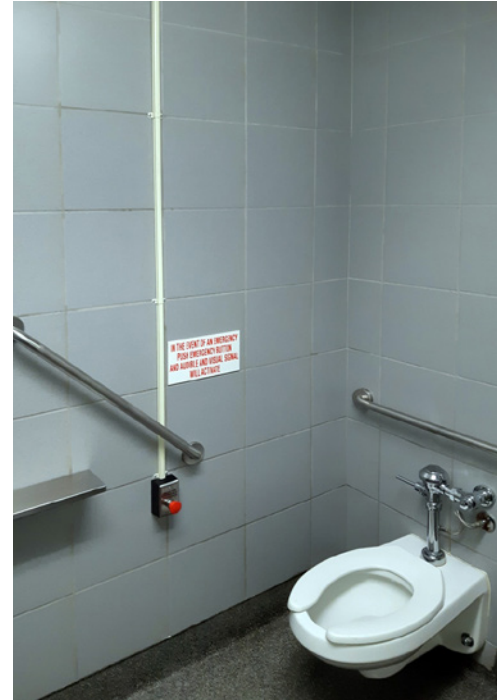
The existing door operator was not installed properly and caused it to wear out prematurely at Costco in Mississauga, ON. In addition the handicap washroom was not up to code.

After a Northern Dock Systems technician came to inspect the equipment, they discovered the existing operator failed because there was no interlock between the dead-bolt lock and the operator. By adding the interlock and installing a new operator properly, the door was then fully functional.

Unfortunately, the technician also discovered that the current washroom setup was not code compliant. To make a code compliant, barrier free and accessible restroom, our technician installed a:

- New operator with control relays for barrier free restroom
- New panic system with horn and strobe
- New push to lock button
- New electric strike to be integrated into the existing door frame
- New illuminated access buttons for entry and exit
