High-Speed Rubbers Doors Replaces Slow Rolling Steel Doors

George Brown College

Toronto, ON

Project Overview

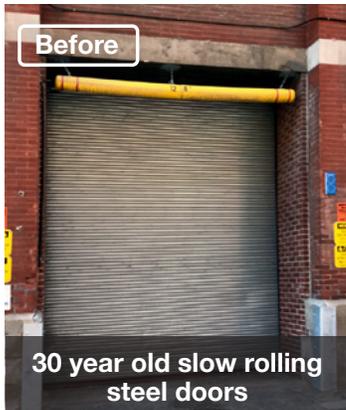
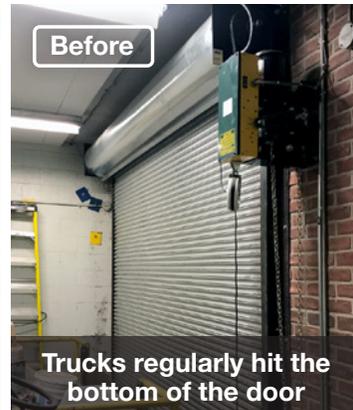
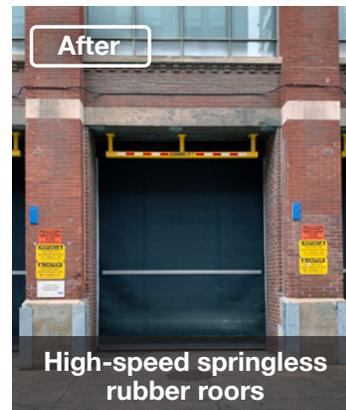
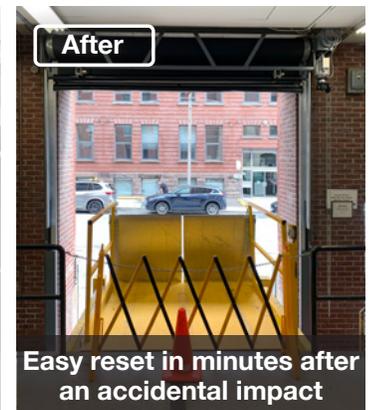
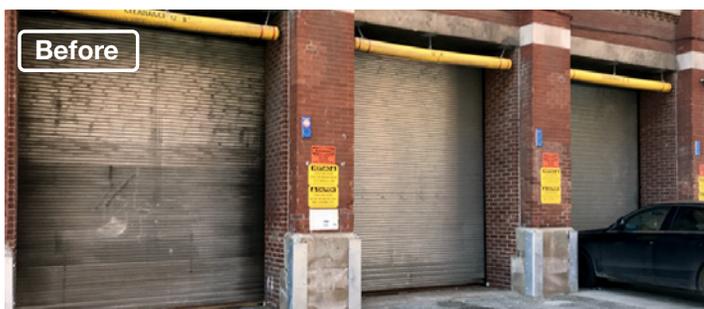
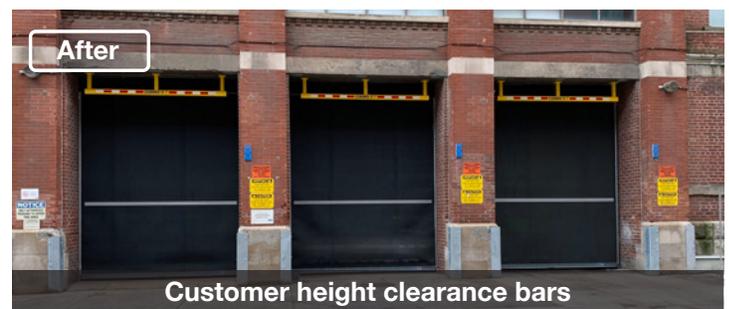
The slow and outdated rolling steel doors at this very busy shipping area in George Brown College required constant service repair calls. Since the 30-year-old doors were so slow, trucks were constantly hitting the bottom of the door and even the barrel. As a result, the door and position would be out of order until we came to repair it. Causing unnecessary downtime and repair costs for the college.

In order to prevent accidental impacts with the door, we installed new [high-speed rubber doors](#) in their loading dock. These doors are much faster and smoother than the previous rolling steel doors because of their springless direct drive operators. Furthermore, these operators are built to last as they have 1,000,000 cycle or 5-year warranty.

In addition to installing the door, we designed, manufactured and installed custom height clearance bars. These bars are bolted with 6-inch wedge anchors at 12 anchor points per clearance bar so trucks will hit the bar and not the door housing. Rather than having the previous plastic height clearance bars that did not stop any impact from trucks.
