Lift Table with Split Aluminum Split Lip
Local Grocery Store

Ridgeway, ON

Project Overview

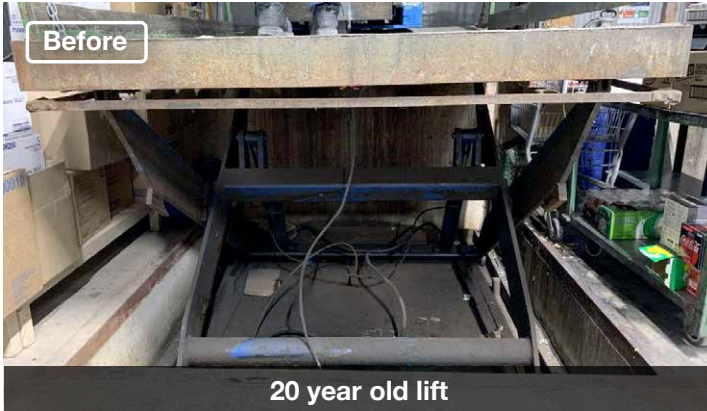
20 year old lift

The existing lift, which was over 20 years old, was nearing the end of its life span. Thus the client was having more frequent operational issues. In addition, the framing of the existing lift was compromised. As a result, the lift table deck was no longer level with the surrounding floor.

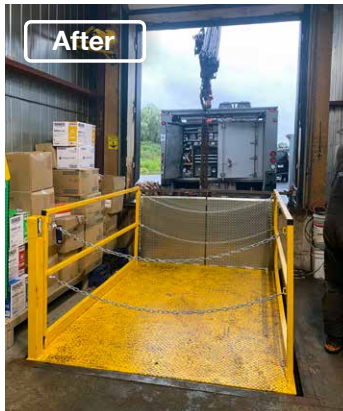
After

By upgrading and replacing the scissor lift that was original to the building with a new [Nordock Dock-Lift \(DL\) Series Scissor Lift](#), the store is well-positioned to ensure reliable and efficient receiving operations long into the future.

Furthermore, we added a deck-mounted control station to the lift to make it easier and more convenient to operate. Also, by adding aluminum split lips, staff can lower onto the truck with less stress and force as was previously required.

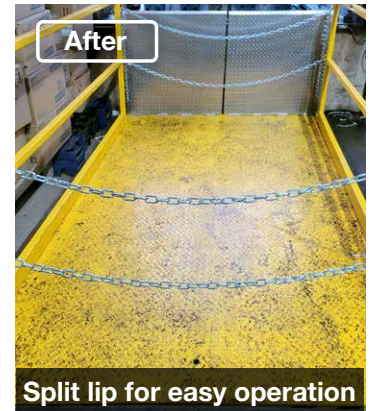
Split lip for easy operation

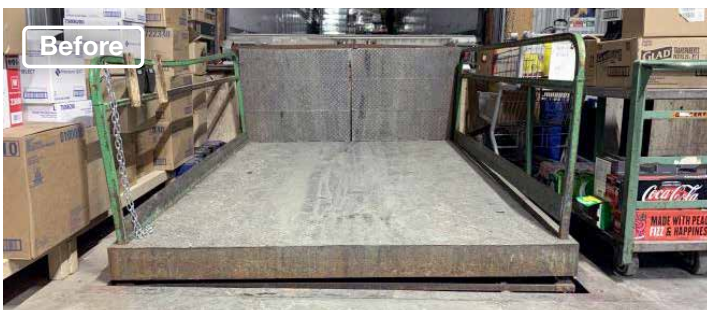
Before

Furthermore, the 36" steel lip did not have dampers or a spring assist, so it was very heavy and difficult to operate for store staff.

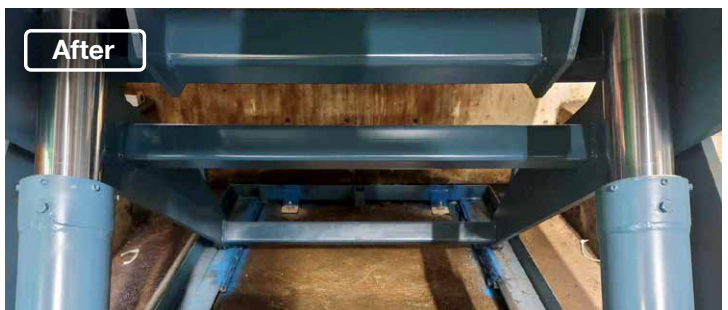
After
