Customer Success Story

## **Double Entrance Swing Doors with Keypad Lockset** National Tank Services

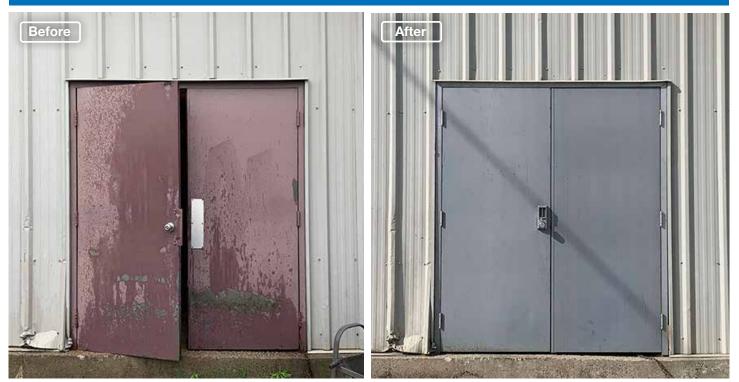
The entrance swing doors to the secondary electrical room had their spines broken and the frame was coming loose at National Tank Services in Mississauga.

Our swing door technician removed the existing frame and entrance door. Next, he installed a new knockdown frame and double doors with tack welded seams for greater strength. Complete with new hinges, top and bottom slide bolts for the inactive door, an astragal and an exterior Unican mechanical keypad lockset for added security.
