New Dock Leveler, Dock Pit, Bumpers and Dock Seal
Truline Contracting and Calgary Warehouse

Calgary, AB

Project Overview

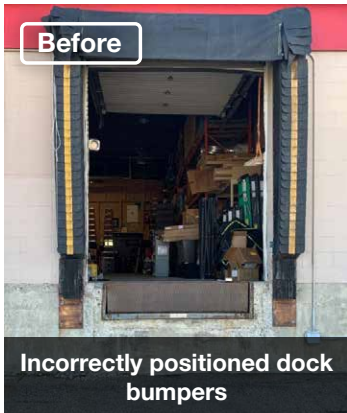
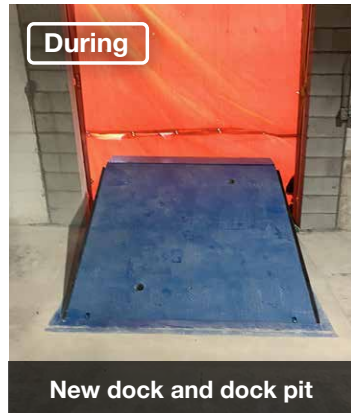
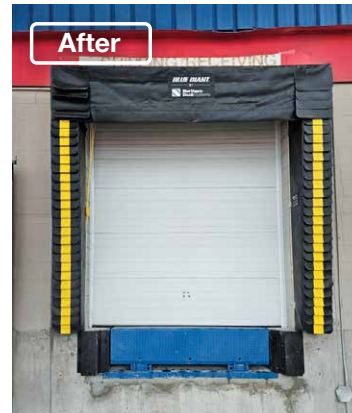
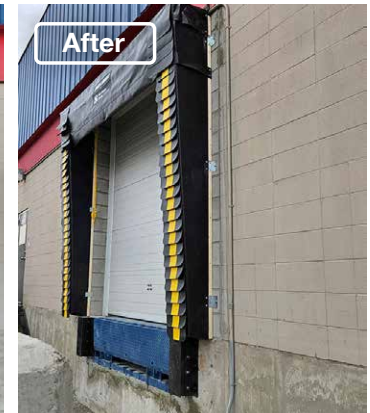
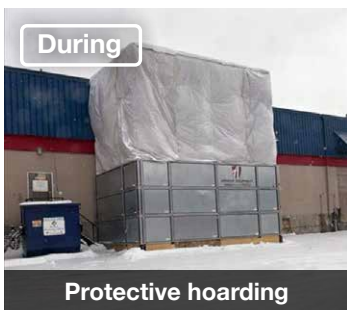
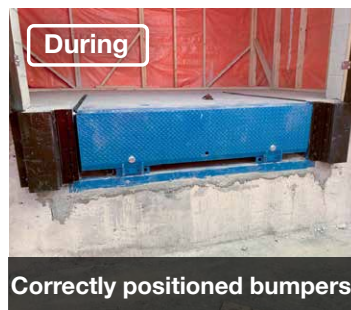
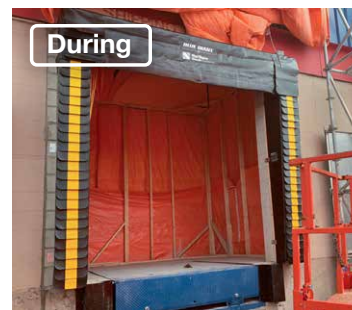
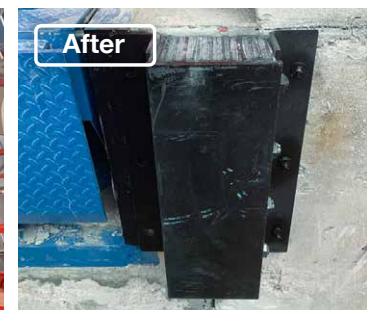
At a warehouse in Calgary, a trailer collided with a dock due to the incline approach and poor weather conditions. The original dock bumpers were incorrectly positioned above the dock height, leaving the dock unprotected. As a result, the collision caused severe damage to both the dock and the building's wall.

We worked with Truline Contracting, who was hired by the insurance company to repair and resolve the issues at this Calgary warehouse. Truline Contracting provided a protective hoarding around the position to create a safe and secure environment for the repairs to be completed.

Once the area was tarped off, our team could cut and remove the damaged mechanical dock leveler, and repair the damaged concrete by pouring a new dock pit. We replaced the old mechanical dock leveler with a new [Blue Giant Mechanical Dock Leveler](#) and installed [Steel Face Dock Bumpers](#) at the appropriate height.

The steel face dock bumpers were 48" and aligned with the dock leveler to protect both the dock and building from any damage. Steel face dock bumpers have a longer life expectancy than laminate dock bumpers and their floating face plate can handle some of the heaviest impacts.

Finally, we installed new [Blue Giant Adjustable Head Curtain Dock Seals](#) that were reverse-tapered to match the incline approach. This helped create a tight seal around the trailers and protect the building.
